A proposal report to the Bureau of Land Management, Safford Field Office, Arizona February-March, 2018 Prepared by Samuel Wershow

Section 1: Overview of the Proposed LWC

Section 3: Description of the Unit Boundary, Routes, and Impacts

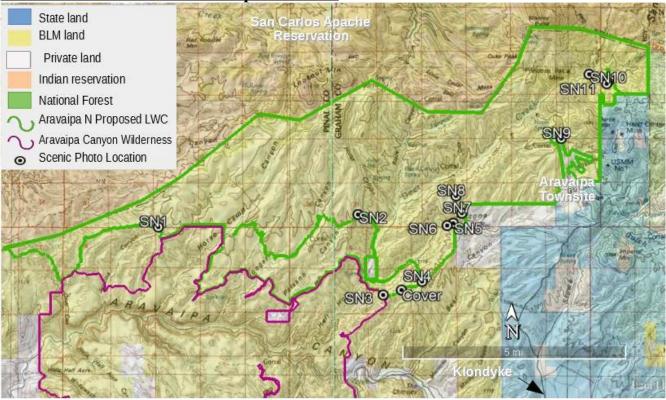
Overview Map – The Aravaipa North proposed LWC encompasses 22,700 acres on the north rim of Aravaipa Canyon, including a number of major tributary canyons. The unit is situated amidst one of southeast Arizona's largest tracts of undeveloped land, about 30 miles southeast of Globe and 40 miles west of Safford. The best access is from the east, via the unpaved Klondyke and Aravaipa Canyon roads. A large portion of its southern boundary is contiguous with the Aravaipa Canyon Wilderness. The unit is bordered by State Trust and National Forest lands to the east, the San Carlos Apache Indian reservation to the north, and by BLM and Indian reservation lands to the west. Three major physiographic regions characterize the unit. The western and northwestern portion of the unit are high, rolling tablelands, dominated by semi-arid grassland and Sonoran scrub communities. Dramatic canyonlands define the southern unit boundary, falling steeply away from the plateau to the north. Sonoran scrub predominates on slopes at lower to middle elevations, while ridgetops are dotted with pinon-juniper woodlands. Canyon bottoms have riparian vegetation such as sycamore and cottonwood. The northeastern portion of the unit is mountainous, with 6,000 foot peaks, and remote valleys, sheltering shady pine forests on north facing slopes and interior chaparral communities on hotter, dryer aspects. The entire unit is wild and natural, offering outstanding opportunities for recreation and solitude. Human impacts are mostly limited to infrastructure of Dry Camp Ranch, a unique cattle operation that practices low impact ranching, primarily via horseback. As a result, most vehicle routes in the unit have been closed and are in the process of revegetation. Overall, this is an outstanding candidate for LWC designation. In addition to containing some of the most scenic, pristine, and remote terrain in the region, it protects a vast portion of the Aravaipa Creek watershed. It is a crucial component of one of Arizona's wilderness jewels and most important riparian habitats.

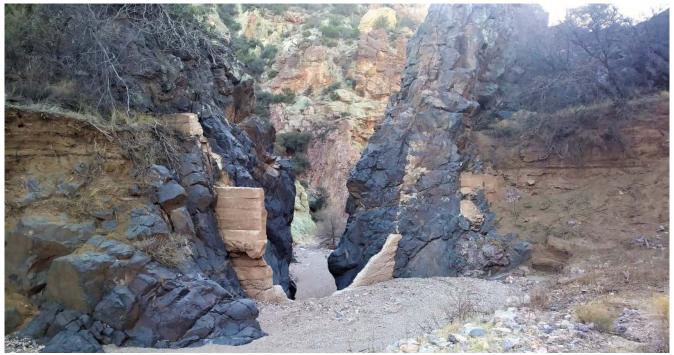
Scenic Photo 6: The narrows in Arizona Gulch, with the remnants of an old dam. The canyon is only a few meters wide here, and there is a 8 foot high rockfall on the other side. This dramatic scenery is a highlight of the area, and the ruins of the dam provide an interesting relic of the areas ranching and mining history.

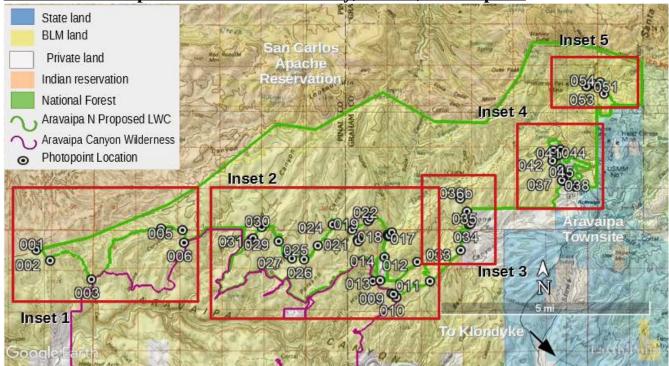
Aravaipa North Reference Map- Map detailing the boundaries of the proposed LWC, the location of inset maps, and the locations of photopoints of boundary features, human impacts, and primitive routes.

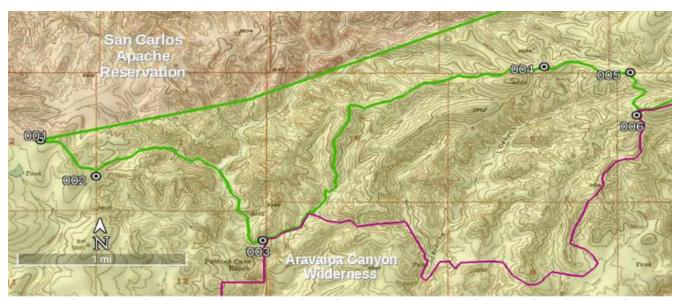
Inset 1 – Photopoints along the southwestern unit boundary. A rough ORV road, accessed via the Painted Cave Ranch, forms the boundary south from the San Carlos reservation. Primitive Ways branch off at 004 and 005, and the boundary becomes the Aravaipa Canyon Wilderness boundary east of 006.

- At 001, the boundary road parallels the San Carlos Apache reservation boundary to the west, and a wilderness inventory road intersects the property boundary from the reservation side.

- 002 is a road junction at a used and maintained water tank. The unit boundary continues east from the junction.
- 003 is a junction, with the unit boundary continuing to the left, and shortly thereafter becoming the boundary of the established Aravaipa Canyon Wilderness.

- 004 is an unmaintained, user created Way, kept open solely by the passage of vehicles.
- 005 shows a gate at the boundary between two grazing allotments. Beyond the gate, the route becomes faint and disappears. This route is a Way, kept open solely by the passage of vehicles The unit boundary continues to south.

- At 006 the boundary road intersects the Aravaipa Canyon Wilderness boundary, forming the unit boundary to the east. The photo looks east along the wilderness boundary. There is no visible road, barrier, or human impact along this boundary. The wildernesses on either side are essentially contiguous. 007 shows another view along the wilderness boundary much further to the east, where it cuts across a deep, rugged canyon,

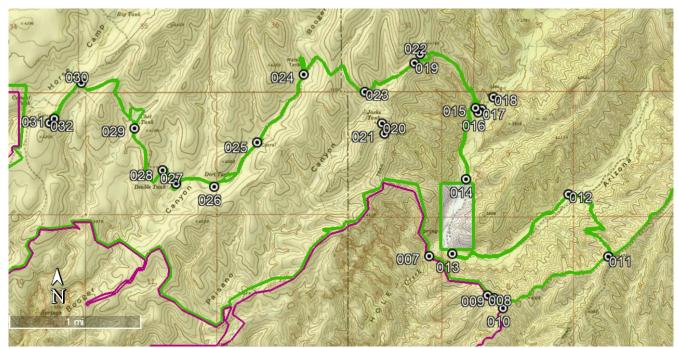
Inset 2 – Impacts and boundary features in the southern portion of the unit. A major cherrystem enters the unit at 011, providing access to the private Dry Camp Ranch inholding (013). The cherrystem continues beyond the ranch to a series of dirt tanks and corrals. West of 008, the southern boundary is contiguous with the Aravaipa Canyon Wilderness.

- 011 is a junction. The unit boundary is to the right (west). The large cherrystem, providing access to the Dry Camp Ranch, begins just to the north of this point.

- 028 shows the typical condition of the cherrystem route, and also shows a non-existent junction with an incorrectly digitized route in the BLM route inventory.

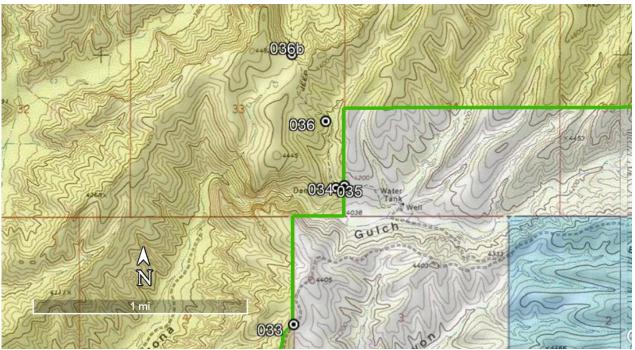
Inset 3 – The Arizona Gulch area in the eastern portion of the unit. A steep, rough, Way climbs out of the gulch, over a ridge, and down into Deer Creek to the North. These routes are primarily used by the local rancher, via horseback, and are not maintained for vehicle use.

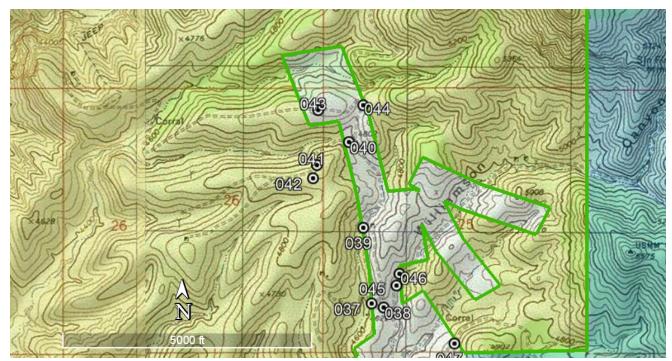
Inset 4 – Impacts and routes near the Aravaipa Townsite along the unit's eastern edge. This was formerly an area with a lot of mining activity, leading to the development of many primitive routes. Most of these are now abandoned and in the process of naturalization.

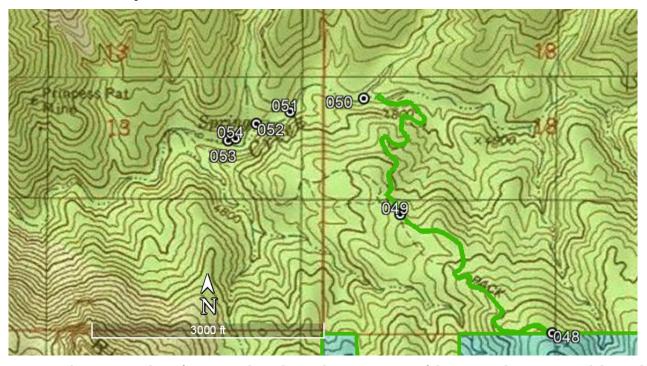
Inset 5 – The upper reaches of Deer Creek, in the northeastern corner of the unit. A cherrystem road descends steeply from 048 to the canyon bottom, becoming a natural wash at 050. There is an abandoned spring development and corral at 053 and 054, minimally impacting the naturalness of this remote, scenic area.
